WSDOT/WASHINGTON STATE FERRIES

**Investigation into the Circumstances Surrounding the
Damage to the Propulsion Drive Motor aboard the
M/V WALLA WALLA on Nov. 4, 2012 while
Undergoing Maintenance at Eagle Harbor
Maintenance Facility**

WSF Investigation Panel

2/25/2013

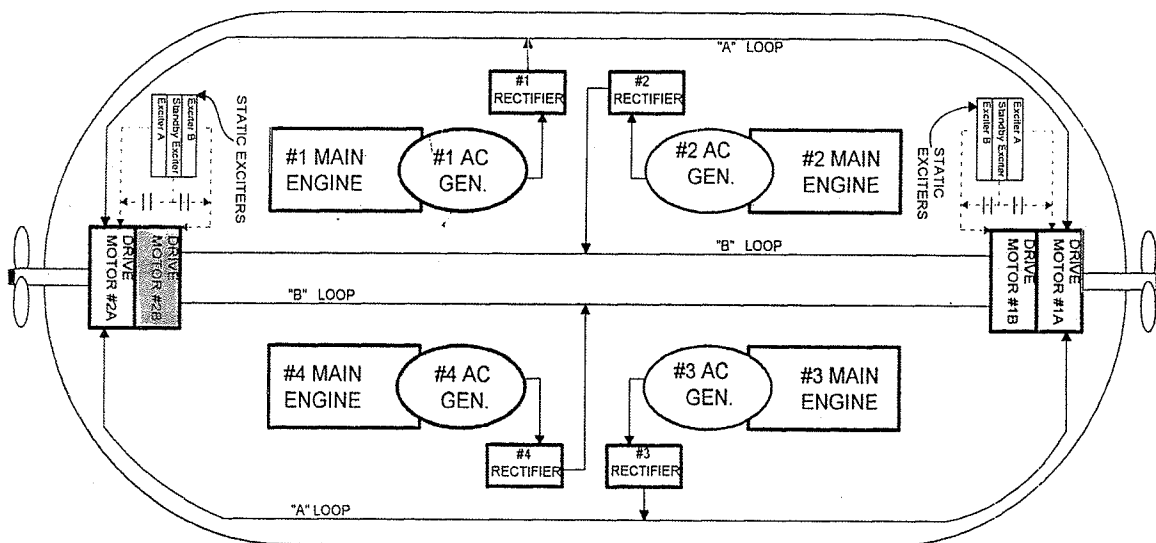
(Note that Diagram A depicts the loops and not the physical locations of the equipment). Each loop has two diesel generator sets supplying power to two drive motors wired in a series circuit. Each Loop (A Loop or B Loop) powers two drive motors which are physically located at opposite ends of the vessel. Motor room #1 contains drive motors #1A and #1B, and motor room #2 contains drive motors #2A and #2B. Normally the vessel will be operated with four main diesel generators running to supply power to all four drive motors. However, when deemed necessary by the operator, one to three alternators may be removed from service and the operation of the vessel can be continued at a reduced power level. The drive motors use direct current, commonly known as DC. The alternating current, commonly known as AC, is output from the main propulsion generators and is converted to DC through four separate rectifier units; from there, the DC is fed directly to each drive motor.

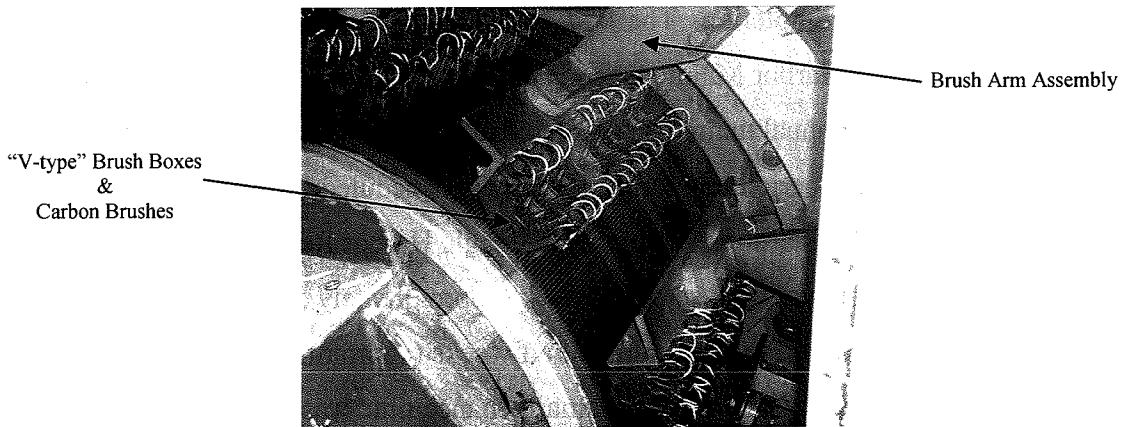
The drive motors on *Walla Walla* contain 12 brush arm assemblies, seen in Figure 1 below. Each brush arm has eight brush boxes mounted to it. These are double, V-type brush boxes

containing two oppositely angled brushes to accommodate the reversing nature of the motor.
(See Attachment 11 and 12 for rigging configuration)

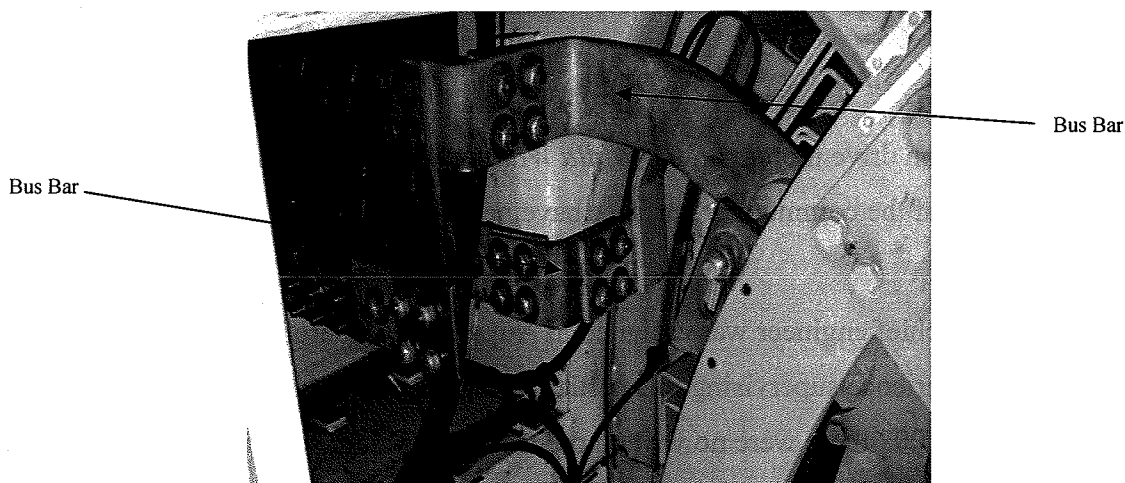
The second method, only to be used on an emergency basis as indicated from the original manufacturer's instruction manual (See Attachment 15), would be to reconfigure drive motor #1A's internal bus bars (See Attachment 16 and Attachment 17) so that its armature circuit was bypassed. A physical depiction of the bus bars is seen in Figure 2 below.

The reconfiguration work would have required all sources of power to A Loop to be removed first. Once these bus bars were reconfigured and the motor covers reinstalled, A Loop could be operated to perform the work of stoning drive motor #2B. The complete lock out of B Loop, including motor #1B and #2B, would still be required. Further, motor exciter #1A should also be locked out as had been done that day. The loop current that flowed through motor #2A to rotate motor #2B for stoning would also flow into motor #1A at the opposite end of the vessel. But that loop current would flow through the internal bypass shunt and not the motor armature and thus the commutator surface and brushes of motor #1A.

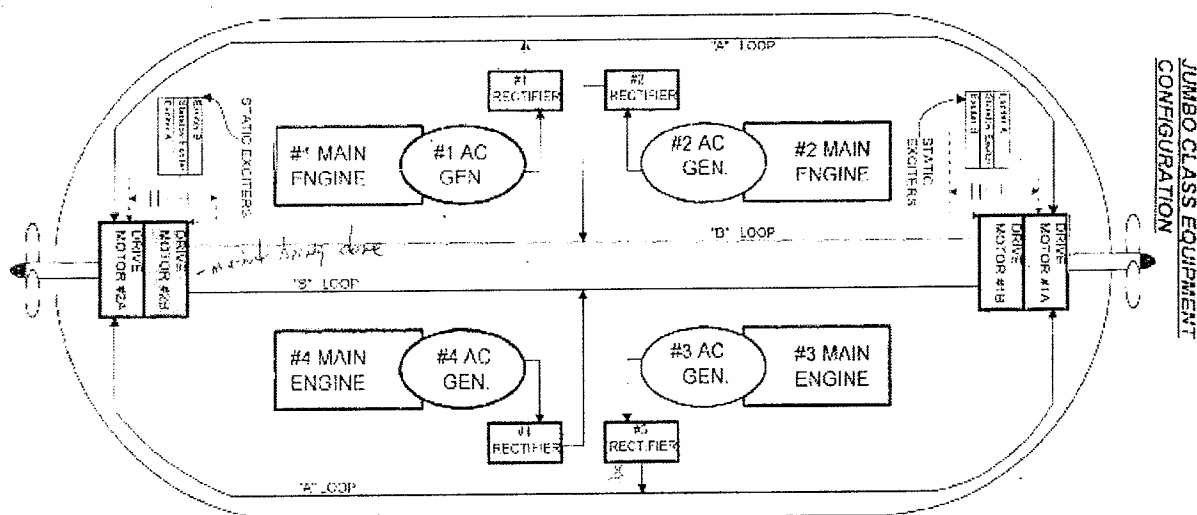
Figure 2

The figure above is being used to illustrate the electrical configuration of the Walla Walla. It is not intended for this diagram to depict the actual physical layout of the vessel. As shown in Figure 2, the Jumbo Class propulsion configuration (Walla Walla) is designed with two propulsion loops. The #3 Main Engine/Generator was providing power to the "A" loop, so that they could turn the #2B motor with the energized 2A motor that was assigned to the A loop. The brushes were all lifted on the 2B motor in order to hand stone the commutator.

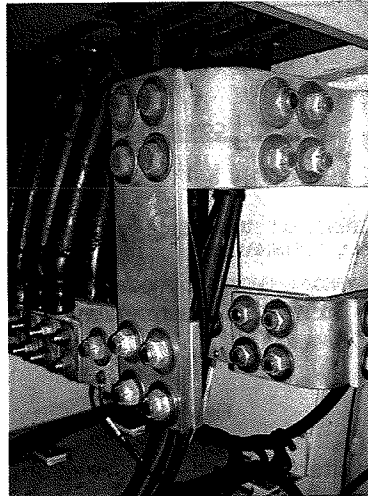
Figure 4 shows the links that are located in an enclosure which is attached to each motor. If a motor has to be isolated completely from the energized propulsion loop, these links must be removed and repositioned so that the loop stays closed, going around the motor circuit and isolating the motor armature from the loop voltage.
